# Manhole Inspection Summary

Manhole # S2100\_030MH

**Location** Address: **BEHIND 2820 AUCHENROTOLY TERR** Cross Street: **EDGEMONT AVE**

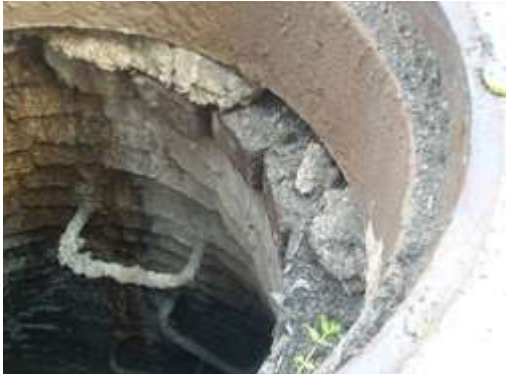
Defect 3

DEBRIS ON CHANNEL AND BENCH

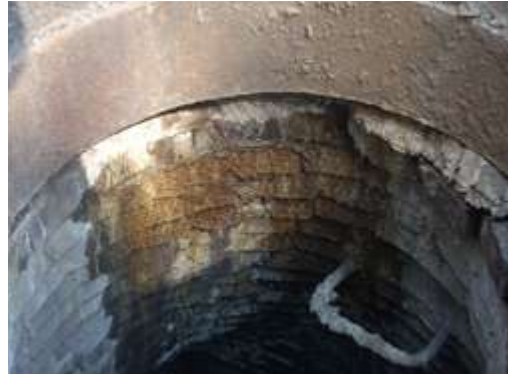
Defect 2

**Chimney / Frame Adjustment** ☒ Exists Material: **Brick** ☐ Parged Height: **3** (in.)  
Condition: ☐ Sound ☐ Cracked ☐ Root Intrusion ☒ **Loose Brick** ☐ Deteriorated  
Infiltration: ☐ None ☒ **Joint** ☐ Cracks ☐ Mortar ☐ Roots ☐ Wall

LOOSE CHIMNEY BRICKS

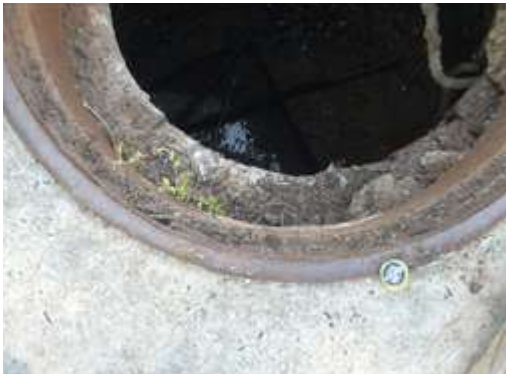
Defect 1

INFILTRATION OF CHIMNEY

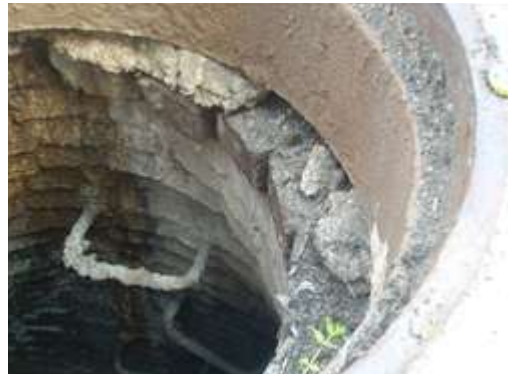
Defect 4

**Frame** Offset: **2** (in.) Condition: ☒ Sound ☐ Cracked ☐ Leaks

FRAME OFFSET

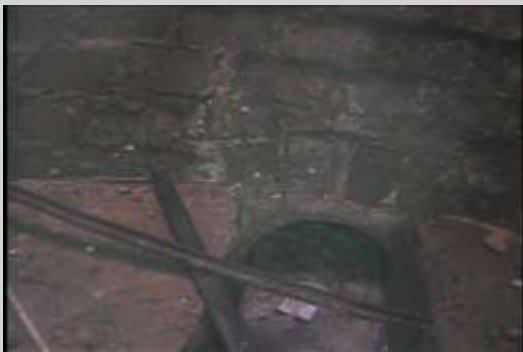
12 O'Clock Outflow

Pipe Height: **8.4** (in.) Rod and Bar (Angled)  
Pipe Material: **Clay** ☐ Pipe Lined  
Invert Depth: **7.29** (ft.) Flow Characteristics: **Slow**  
Deposits: ☐ None ☐ Mud ☐ Sludge ☒ **Debris** ☐ Grease  
Silt Depth: **3** (in.) Deposits Extent: **Medium**  
Infiltration: **None** Pipe Seal Cond: **Sound**

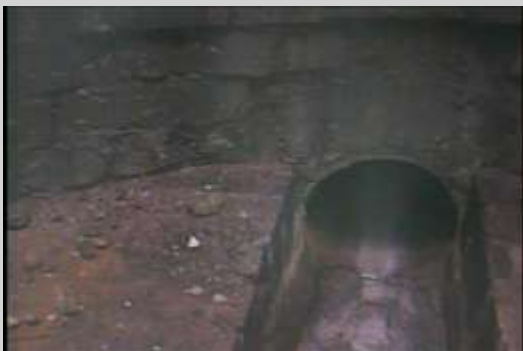
9 O'Clock Inflow

Pipe Height: **8.4** (in.) Rod and Bar (Angled)  
Pipe Material: **Clay** ☐ Pipe Lined  
Invert Depth: **7.10** (ft.) Flow Characteristics: **Slow**  
Deposits: ☒ **None** ☐ Mud ☐ Sludge ☐ Debris ☐ Grease  
Silt Depth: (in.) Deposits Extent:  
Infiltration: **None** Pipe Seal Cond: **Sound**
